Investigation into loss of communications

Loss of communication between controllers and pilots is a key issue for aviation safety. This article reports on the main causes currently identified, what EUROCONTROL and its stakeholders are doing to investigate how to resolve the problem and what the next steps might be.

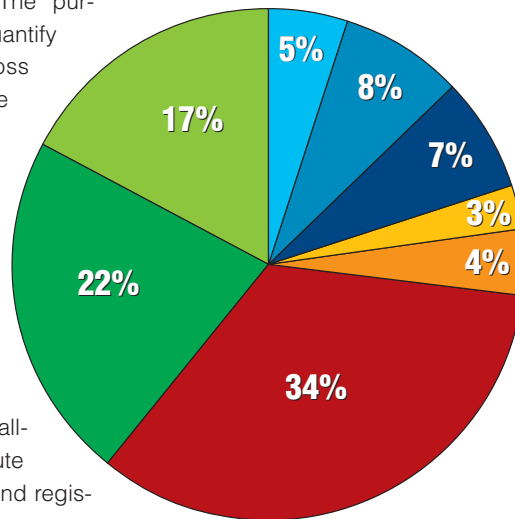
Based on the reported symptoms and with the support of IATA for interrogating airlines shortly after each PLOC, about 32% of the reported PLOC (for the years 2004 and 2005) can be allocated to one of the identified PLOC profiles (see pie chart).

The importance of each profile in this database is of course influenced by the profiles of a few major contributors. As COMLOSS awareness and reporting are expanding, the relative importance of each PLOC profile is expected to evolve.

Unfortunately some 68% of the reported events still do not contain enough detail to be explained and categorised. Recurrent profiles emerging from the report database include:

- Airborne radio failure
- Frequency tuned incorrectly
- Inadvertently changed radio selector
- Radio volume too low or off
- Suspected MultiCarrier - related issue
- Suspected PLOC Type A (silent channel; if relay attempted, no success)
- ATC forgot to hand over, or Wrong Freq assigned by ATC, or Readback/Hearback error
- Radio selection error by aircrew (e.g.: still on previous sector)
