EUROCONTROL Voluntary ATM Incident Reporting (EVAIR) Bulletin No 19

2012 – 2016

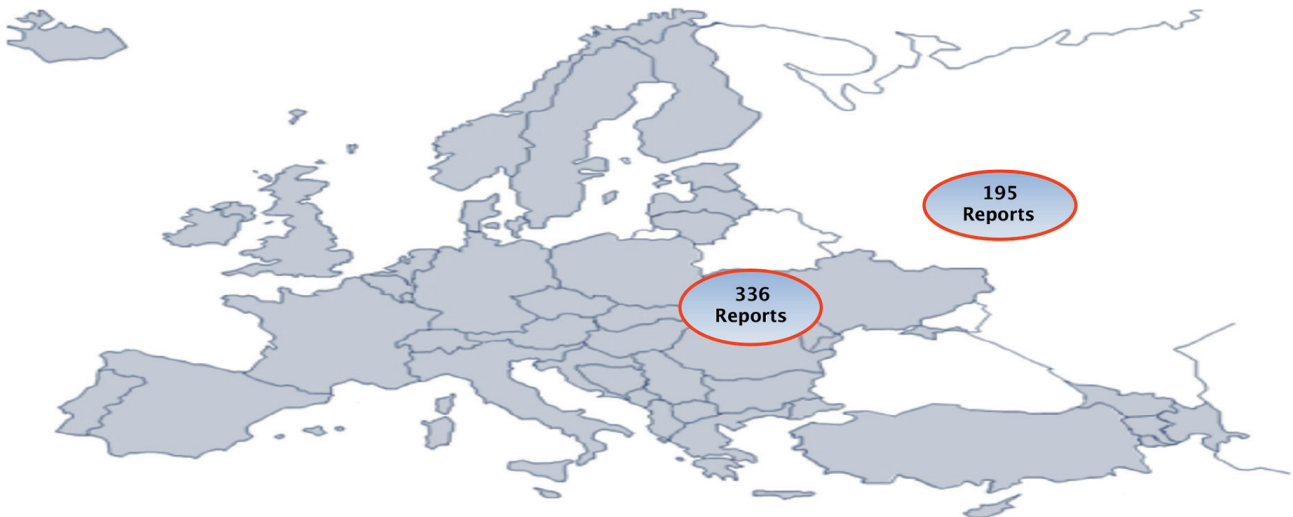
Figure 50: GPS outages- spread within ECAC and non-ECAC regions 2013 - 2016

Looking at the spread of GPS outages (Figures 50 and 51) ECAC airspace is more affected than non-ECAC airspace. In this regard, we would point out that most of the ECAC outages occurred within the ECAC states on the boundary with non-ECAC states. A certain number of reports occurred exactly on the boundary, but for some reports we were unable to identify the location.
